Therm iR Ltd

Sample Report No1

Industrial plant room survey

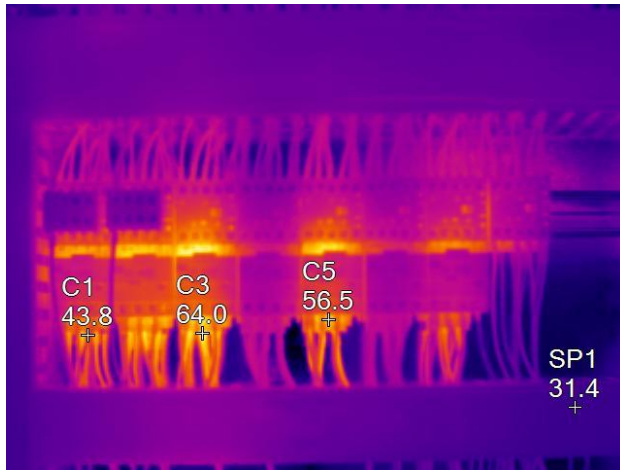
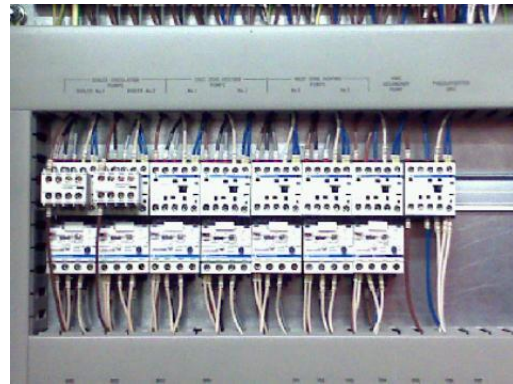
001.IS2

Temperature Value Explanation
SP1 used as a local Ambient temperature value. For referencing against other noted values.
$C3 - C1 = 20.2^{\circ}\text{C}$
$C3 - C5 = 7.5^{\circ}\text{C}$
Max rise over SP1 = 32.6°C

Location	Main Boiler Room	Fault Severity	low
Description	Control panel BR1	Date of Survey	15 th August 2015
Full Load Rating	n/a	Other.	
Actual Load	n/a

Image Analysis
Contactors 'C3' slightly elevated temperature compared to C1, C2 and C5. Check load current and application of this contactor at next convenient maintenance schedule. May be indicative of overload and degenerative condition.

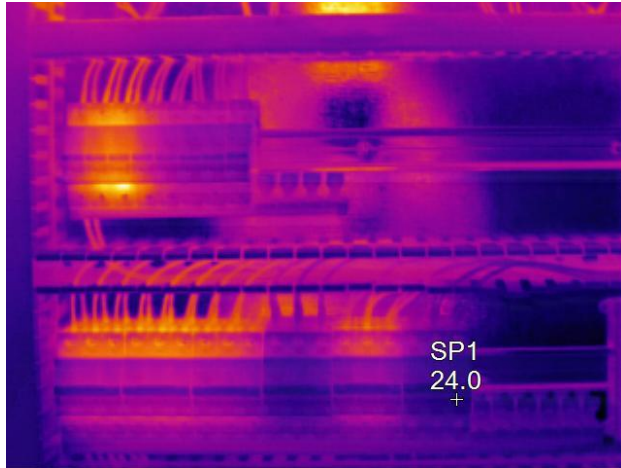
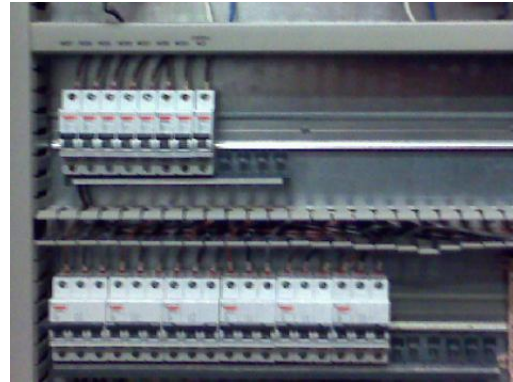
002.IS2

Image Analysis
This image showing MCB protection devices. No issues evident

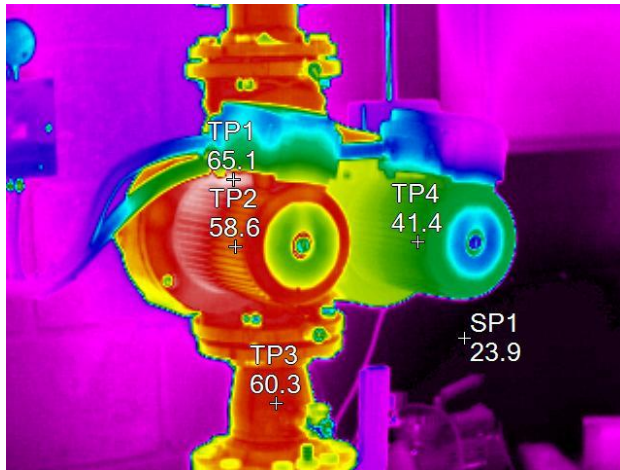
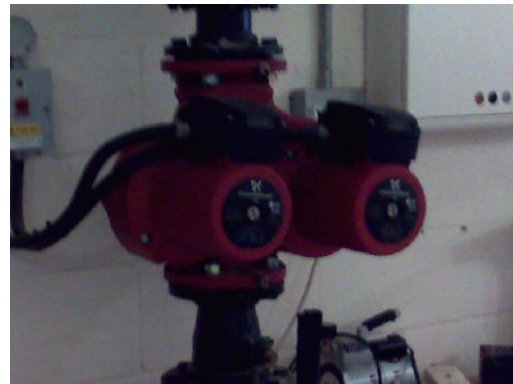
003.IS2

Temperature Value Explanation
Maximum motor temperature seen as 65.1 °C. Compared to inlet temperature of 60.3 shows this motor is running at a rise of only 4.8 °C.

Image Analysis
Circulation pump and motor showing minimal motor temp rise compared to inlet temperature. No issues represented. Image will now form part of the ongoing preventative maintenance program.

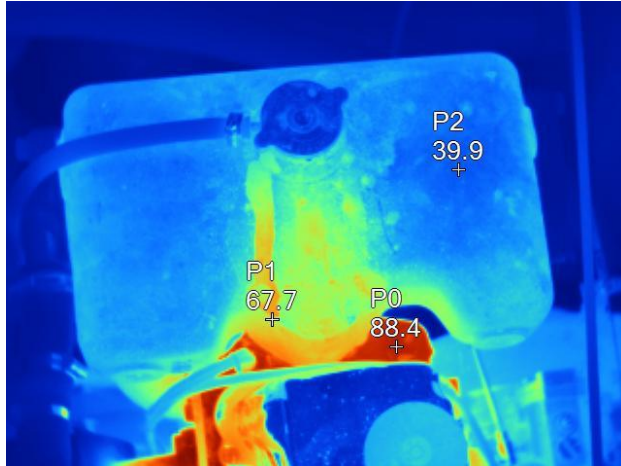
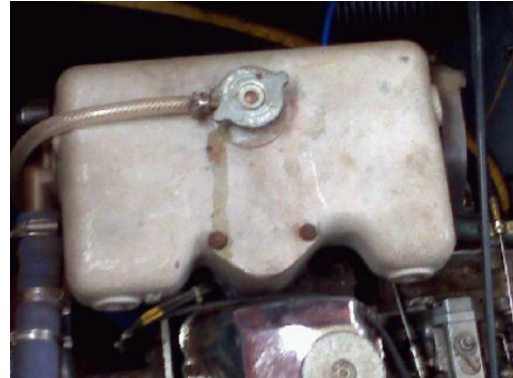
004.is2

Temperature Value Explanation
Main engine block P1 reached max temp prior to thermostat opening. P2 is the header tank / water exchanger temperature. P1 showing thermostat on point of opening.

Image Analysis
<p>The survey was requested to determine correct operation of the cooling system thermostat. Opening expected at 85°C. The following 2 images show the thermostat operating and the engine block temperature lowering to final operating level of around 83°C.</p> <p>Correct operation of the thermostat was visualized and point of operation is as stated approx 80-85°C.</p> <p>Engine temperature gauges also show correct temperature of the engine.</p>

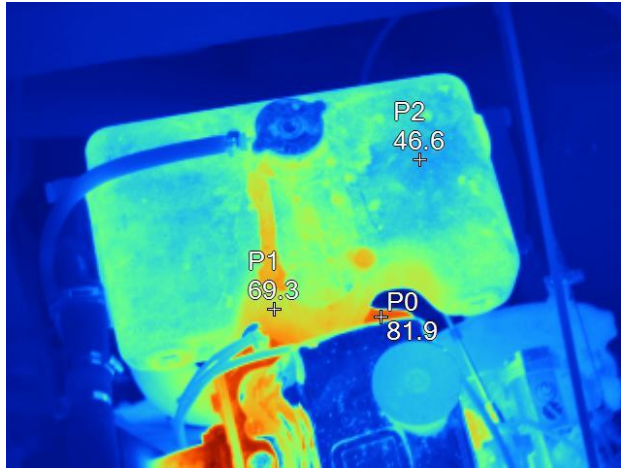
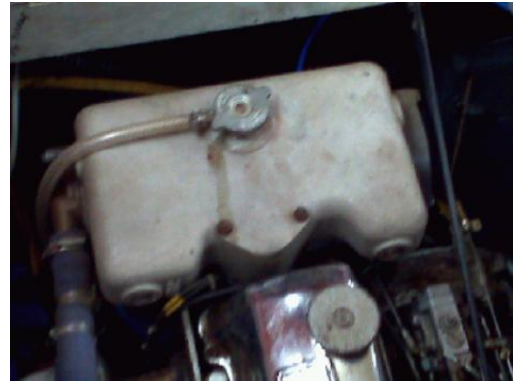
005.is2

Temperature Value Explanation
Main engine block P1 temperature now decreasing after thermostat opening. P2 is the header tank / water exchanger temperature. P1 showing thermostat now opening.

Image Analysis
Thermostat has now started to open. Engine block temperature shown to decrease and the exchanger temperature rising.

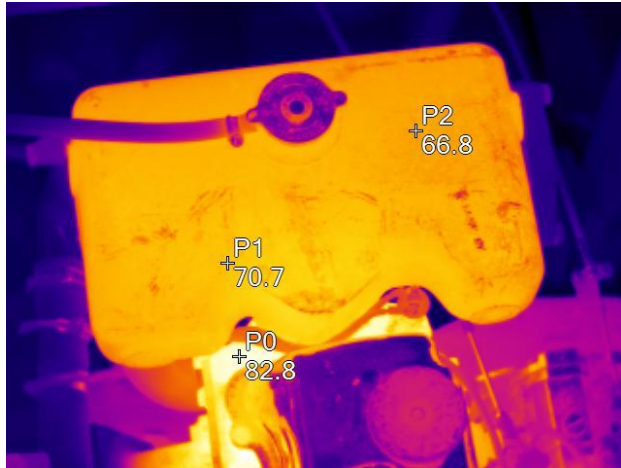
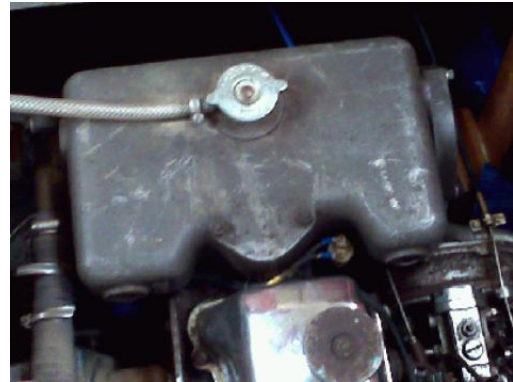
006.IS2

Temperature Value Explanation
This final image is showing stable temperatures after the engine has been allowed to reach final operating temperature.

Image Analysis
The engine has been allowed to settle at final operating temperatures for the current load of approx 50%. The final temperatures shown are indicative of an efficient cooling system and a correctly functioning thermostat.

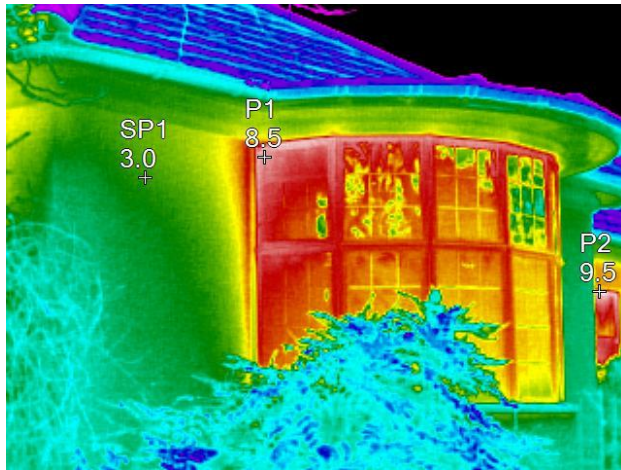
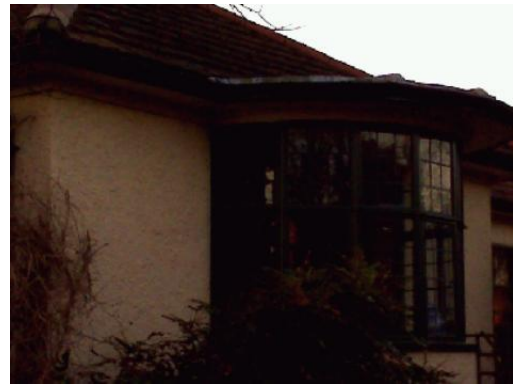
007.IS2

Location	Front of house	Insulation Severity	medium
Description	Window survey	Date of Survey	08 th January 2014
Outside Temp	2°C	Other.	Outside temp stable and no rain for 24 hours
Internal Temp	Lounge 15°C Sitting room 19°C

Image Analysis
<p>This image showing the poor insulation of old style single glazed windows.</p> <p>Further insulation in the form of secondary glazing, or ideally replaced with modern double glazed units.</p>

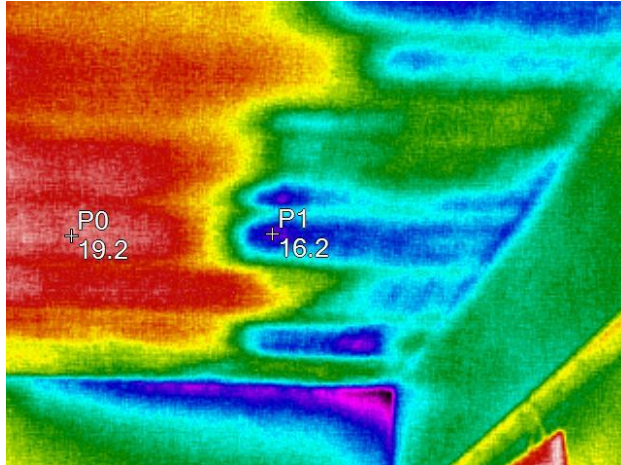
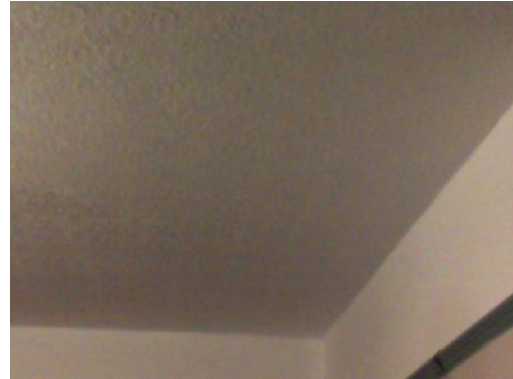
008.IS2

Temperature Value Explanation
Area to the right nearest wall shows distinct line of poor or missing loft insulation.

Location	Sitting room	Insulation Severity	high
Description	Ceiling / loft insulation	Date of Survey	08 th January 2014
Outside Temp	2°C	Other.	
Internal Temp	Sitting room 19°C		Outside temp stable and no rain for 24 hours

Image Analysis
<p>This image showing area of very poor or missing loft insulation (shown in progressively blue colouration).</p> <p>Loft space investigation required to establish extent of problem.</p>

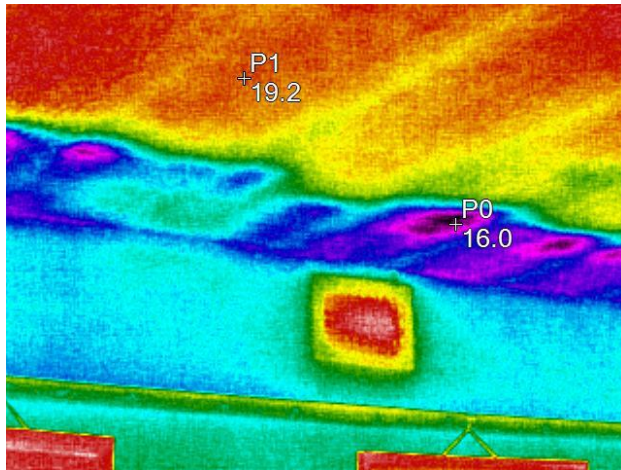
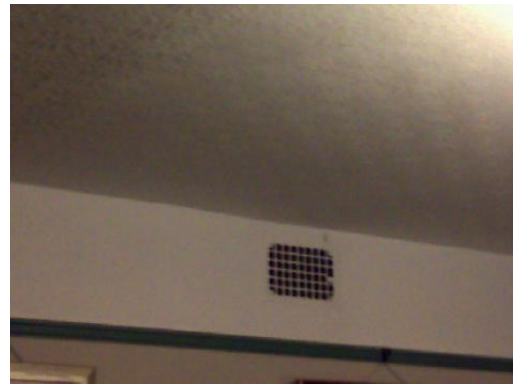
009.IS2

Location	Sitting room	Insulation Severity	high
Description	Ceiling / loft insulation	Date of Survey	08 th January 2014
Outside Temp	2°C	Other.	Outside temp stable and no rain for 24 hours
Internal Temp	Sitting room 19°C

Image Analysis
Continuation of image '008', showing very defined area of poor insulation.

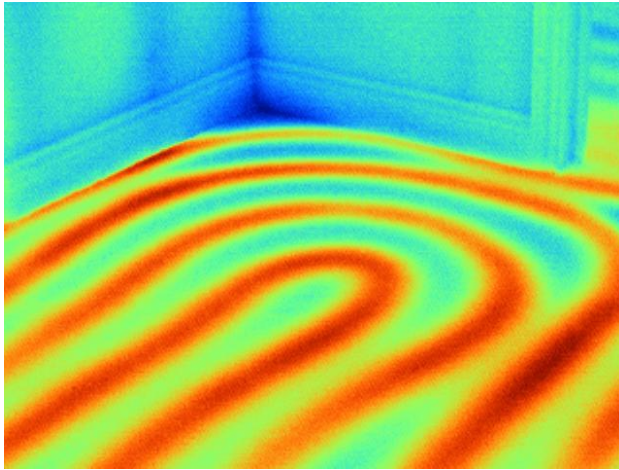
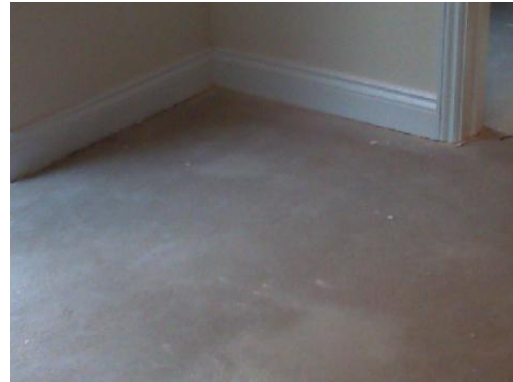
010.IS2

Image Analysis
<p>This image clearly shows the position of the buried underfloor heating pipe run, within the solid screeded floor.</p> <p>Included in this sample report to demonstrate the usefulness of Thermal Imaging in following situations :-</p> <ul style="list-style-type: none"> • Locating buried heating pipe runs when fixing objects mechanically to the floor • Location of leaking buried pipe runs, minimize destructive access to the floor • Determine effectiveness of the Under Floor heating system

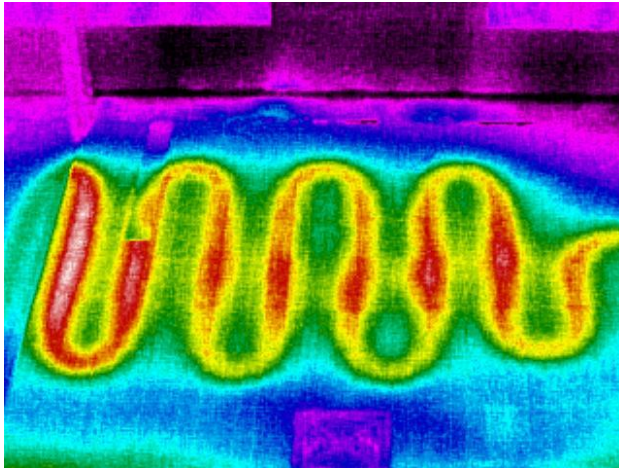
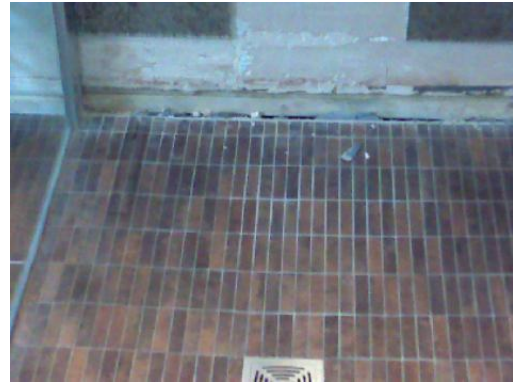
011.IS2

Image Analysis
<p>The client was carrying out tile remedial works along the top wall. The tile along the top edge was required to be cut back slightly to affect the repairs to the floor. Due to the electric underfloor heating elements being present, the extent of tile removal was not known. Following the Thermal Imaging survey, the amount of tile that could be cut back was established and works could proceed safely.</p> <p>This saved the task of replacing the entire Bathroom flooring plus installing new electric under tile heating elements.</p>

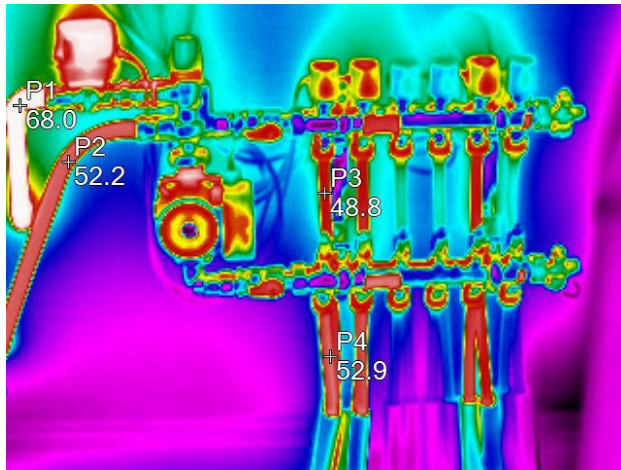
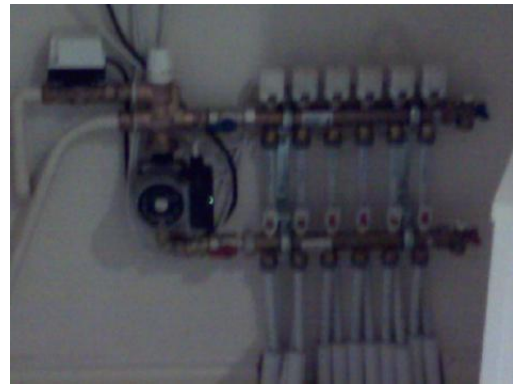
012.IS2

Image Analysis
<p>This Thermal Image Survey was required to quickly set the blend temperature of the system and determine equal feeds to each of underfloor heating circuit.</p>
